SAWS Consent Degree SSO Reduction Program

Jeff Haby, P.E.

Director – Sewer System Improvements

Westside Creeks Oversight Committee Meeting

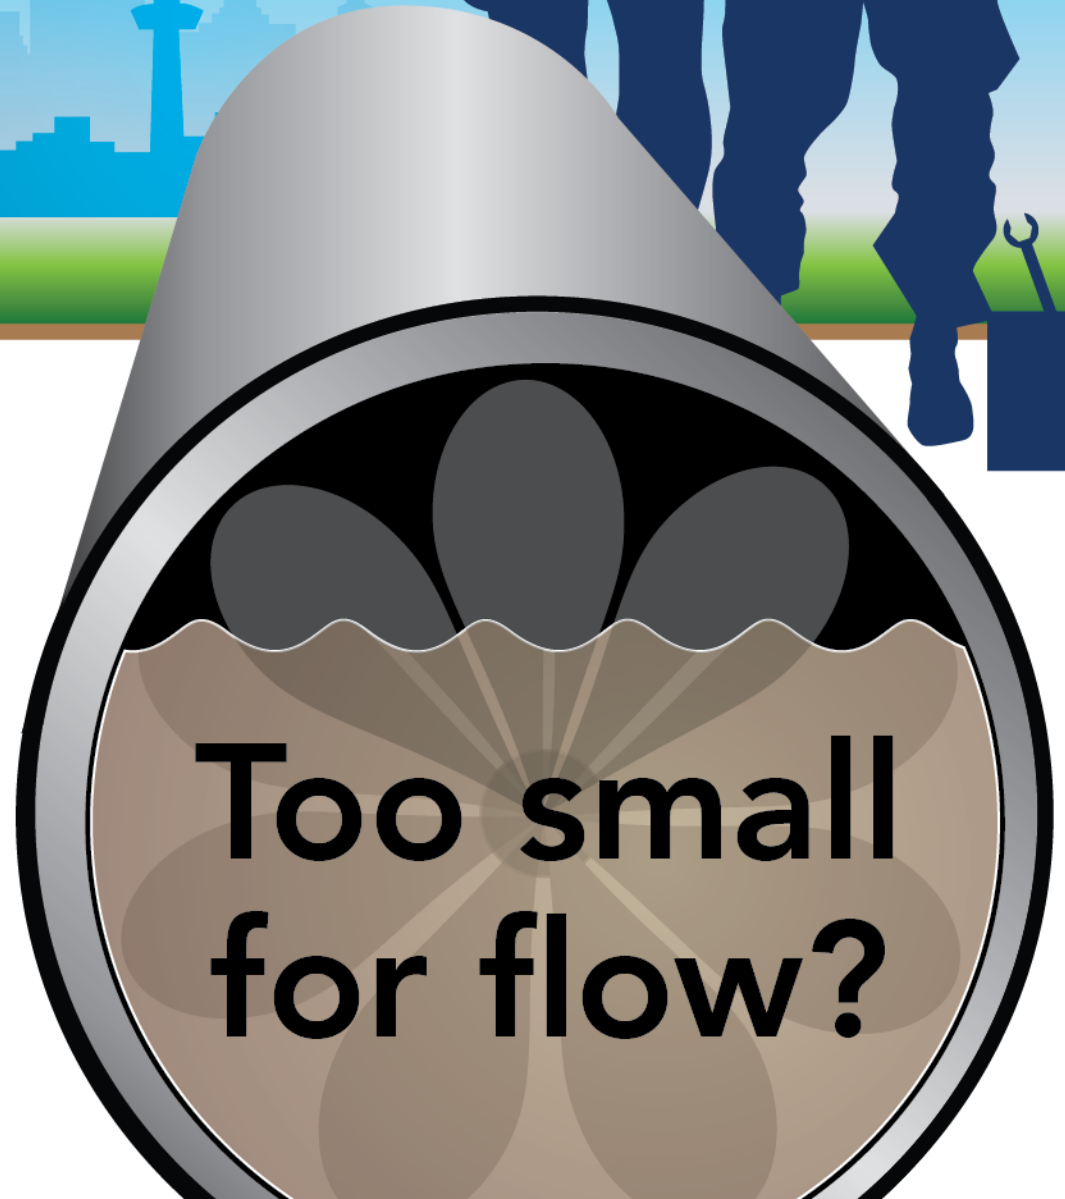
Pipes that are too small for the flow may be upsized to manage identified capacity constraint(s).

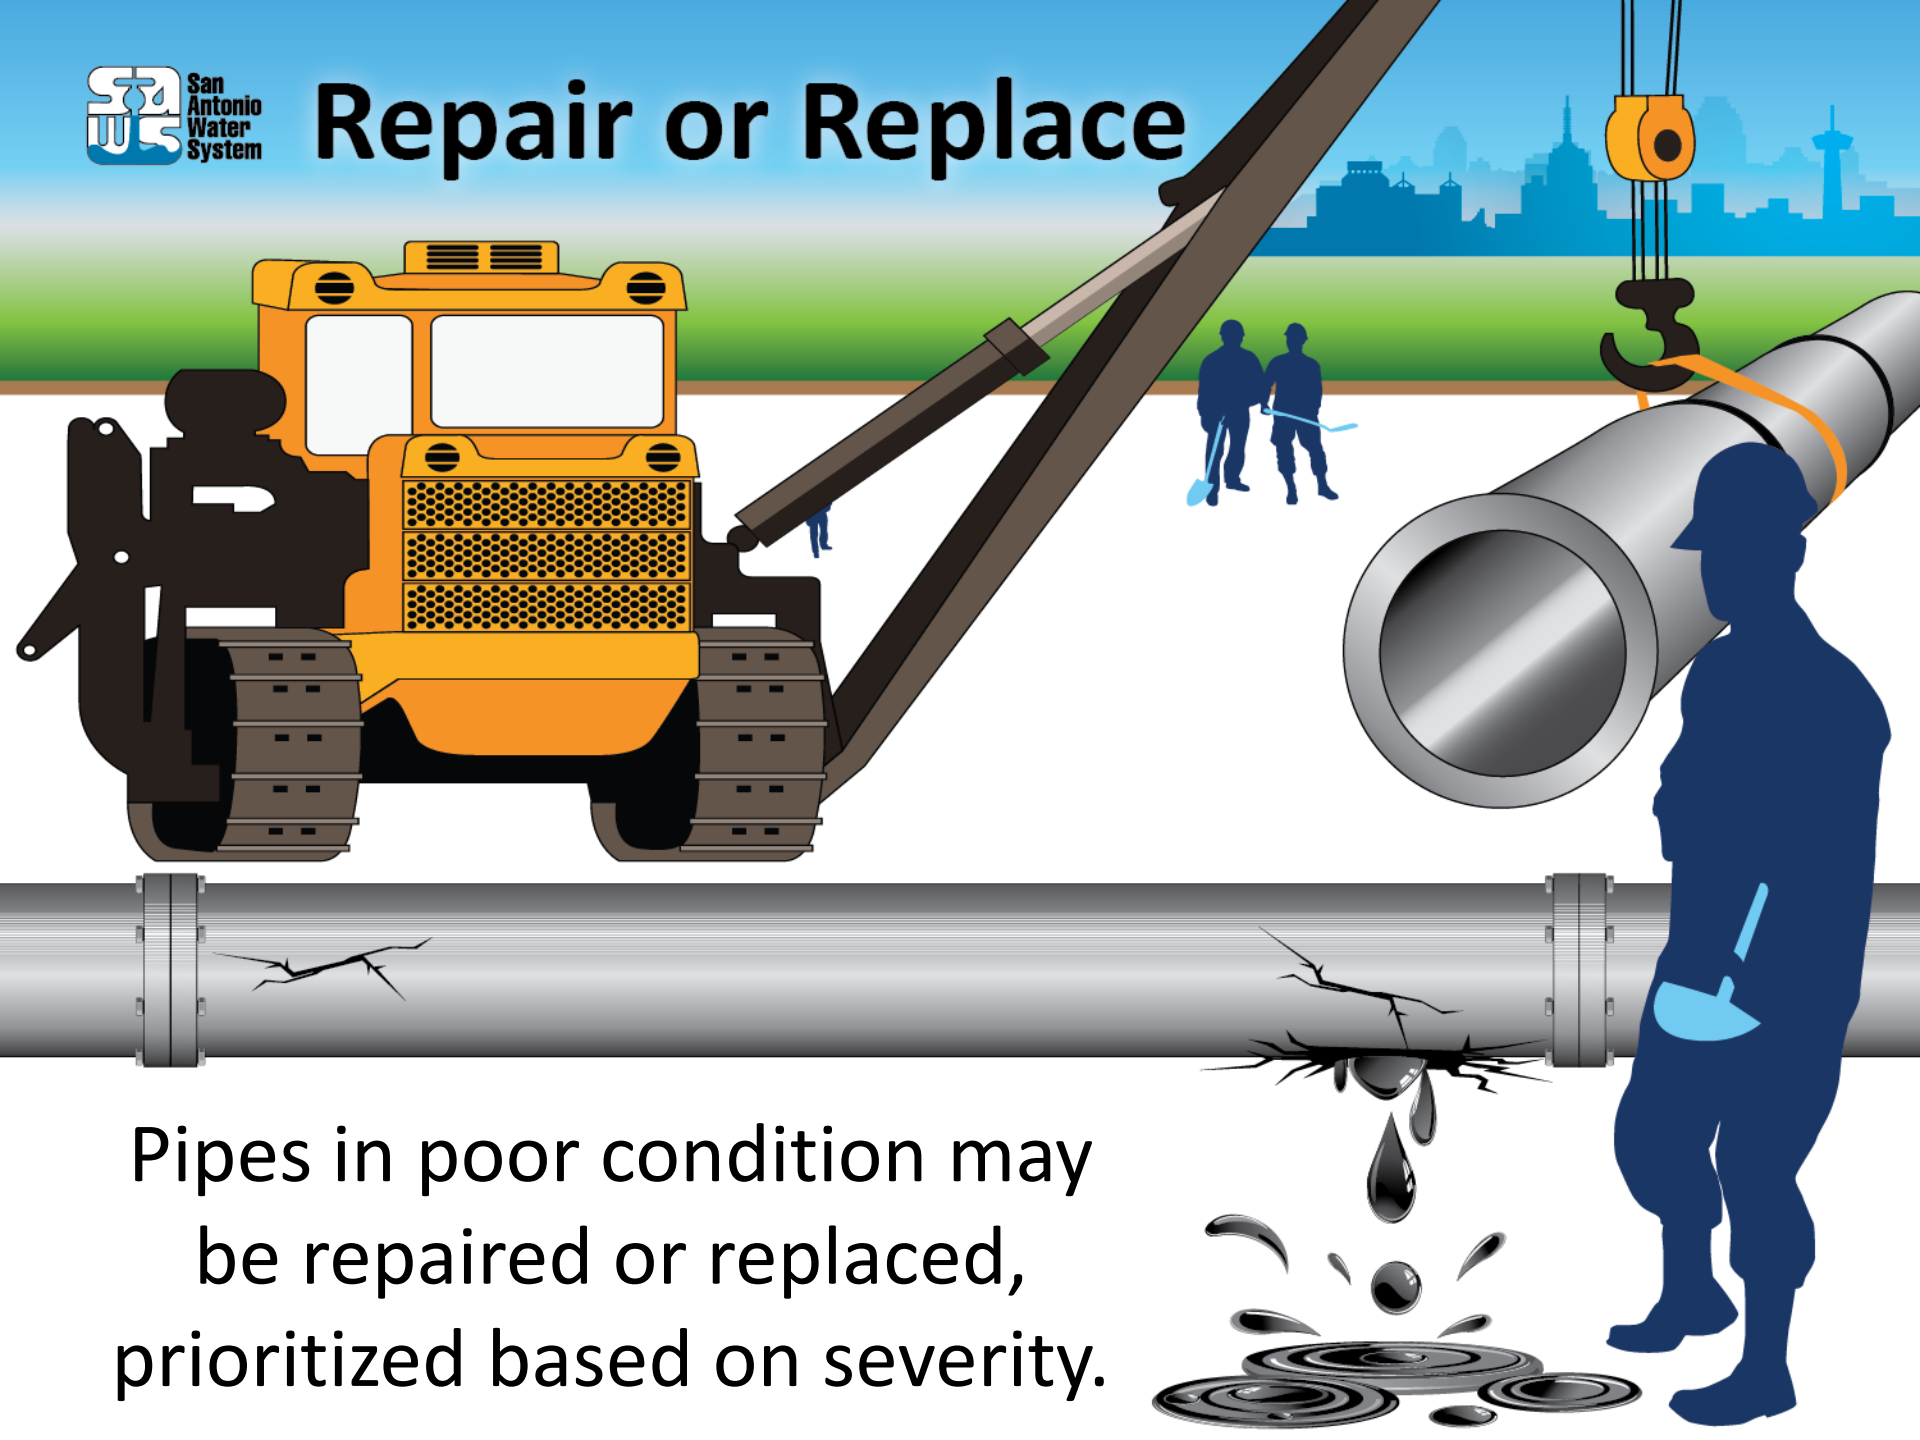
Repair or Replace

Pipes in poor condition may be repaired or replaced, prioritized based on severity.

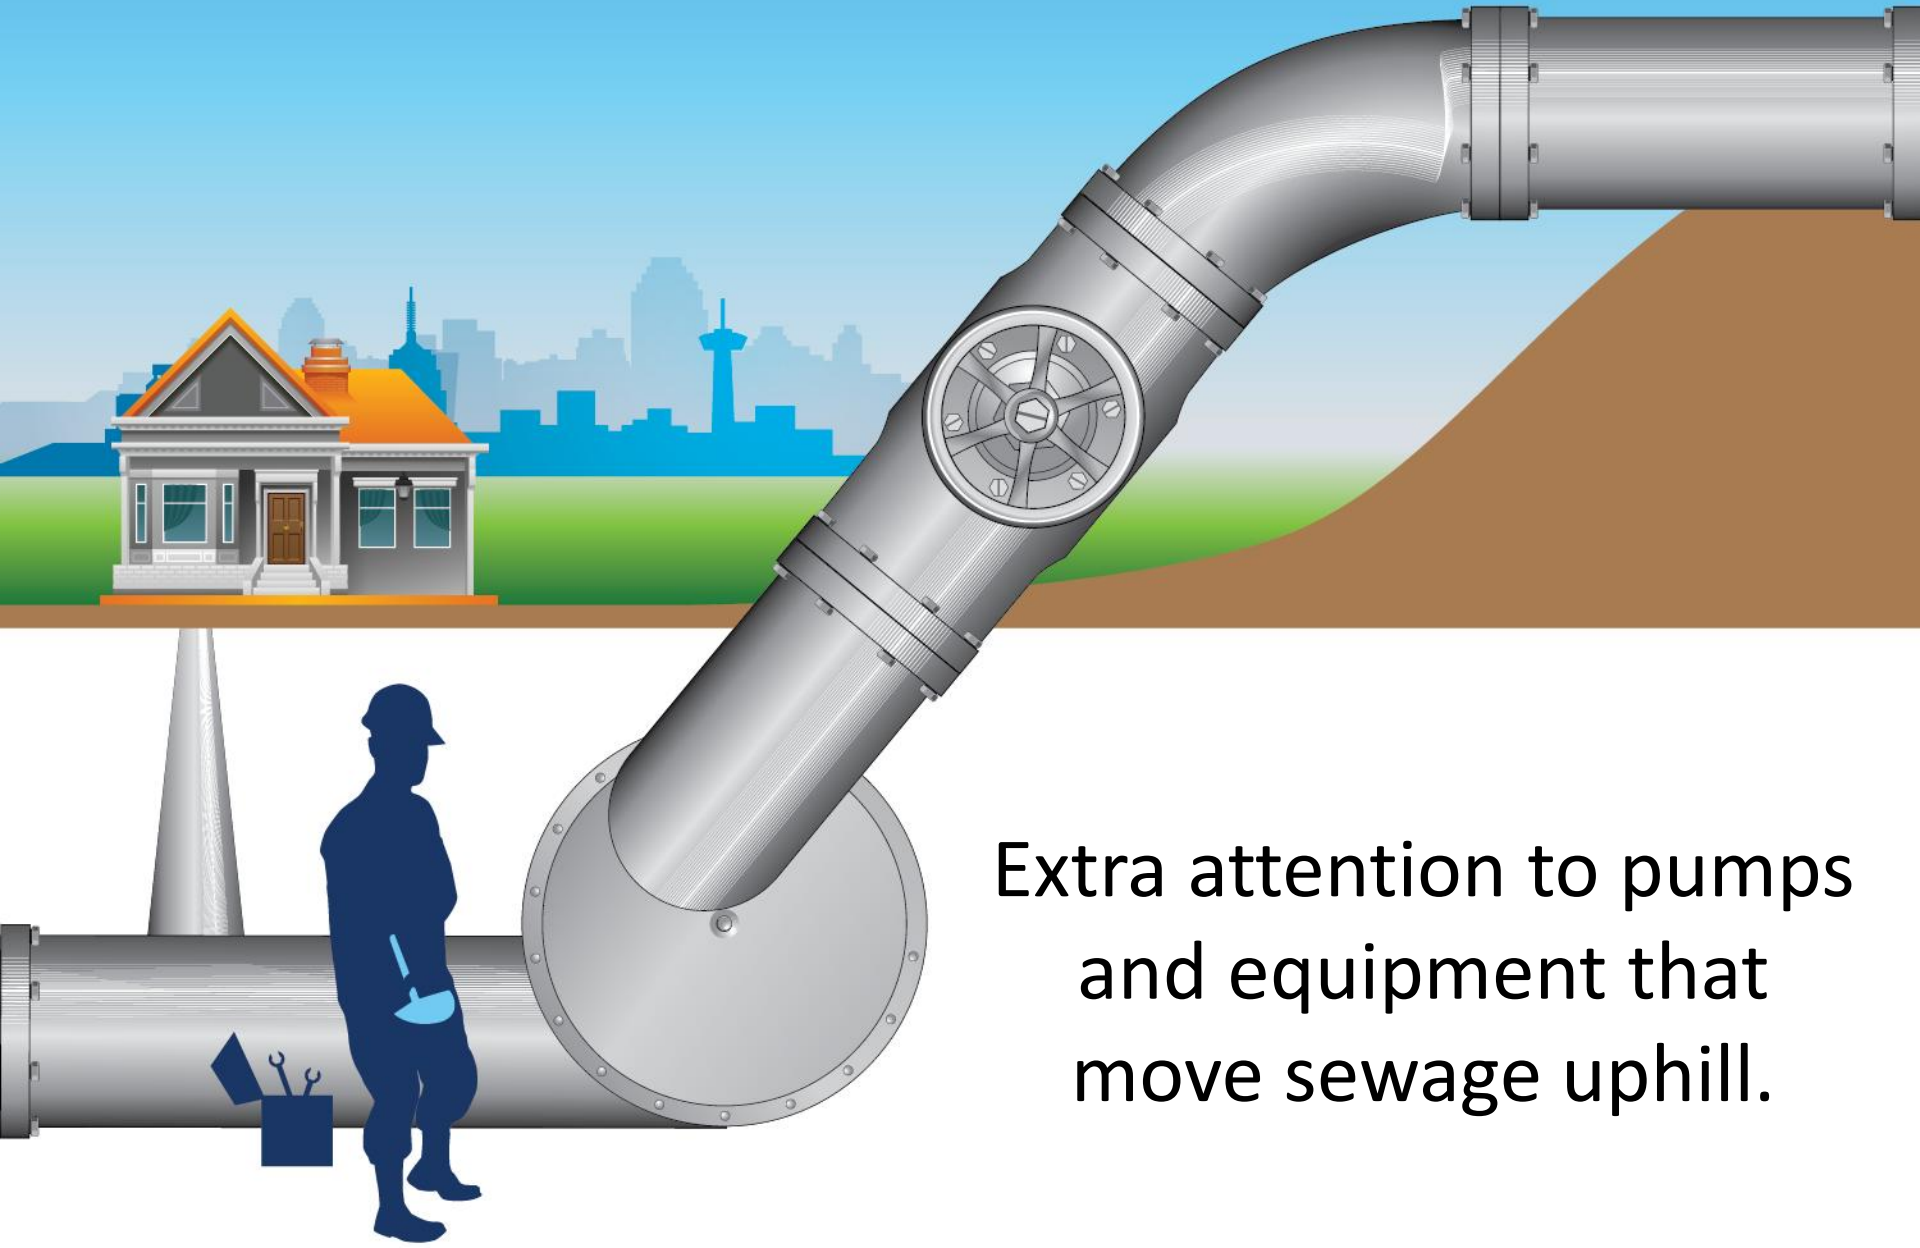
Fix or Remove Lift Stations

Extra attention to pumps and equipment that move sewage uphill.

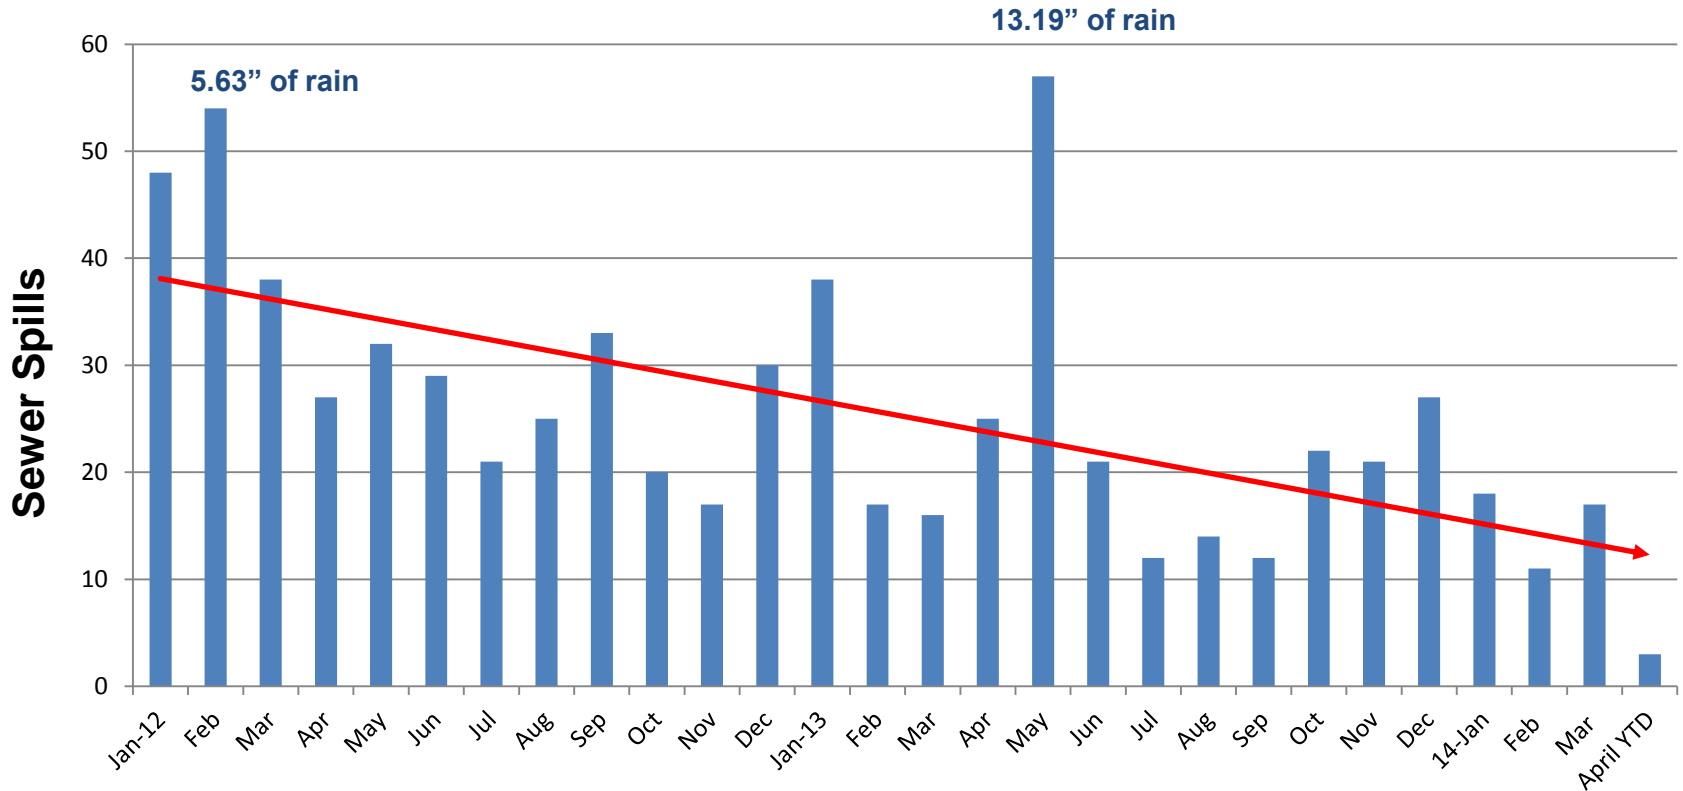
Sewer Spills Reduced 2012-2014 YTD

Sewer Investments are Working
